Safety First Briefing

August 2017

Accidents and Incidents

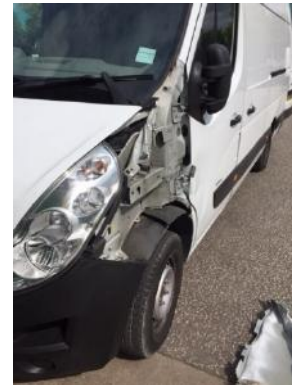
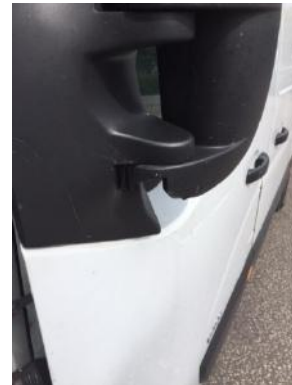
07/07/17 – NU15BBE

Returning home from a shift the driver attempted to pass between two drop side vehicles parked and misjudged the gap. The result was that the N/S mirror housing was cracked and damaged and damage to a panel on the same side.

Along with misjudging the size of the gap the driver was also traveling too quickly meaning he could not stop and reduce the damage to the vehicle.

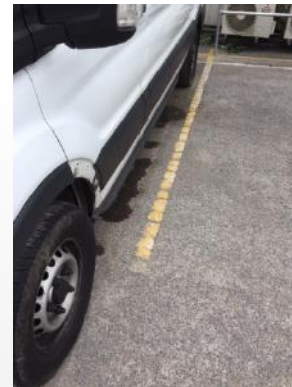
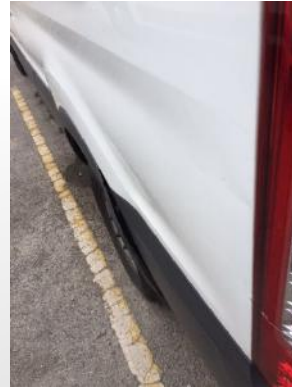
19/7/17 – NL64KDF

Working on site the driver was asked to reverse down an access which was tight resulting in damage the length of the N/S of the vehicle.

The driver should have alerted his site supervisor that the access was not suitable so that an alternative could be found or asked for a trained banksman to assist.

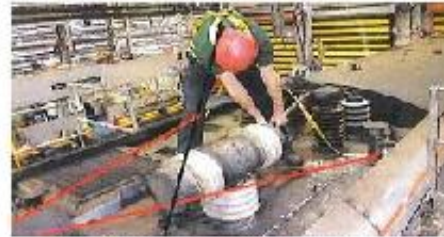
Figure 10: Lanyards correctly attached and connected to the end of the safety harness allowing access to overheads

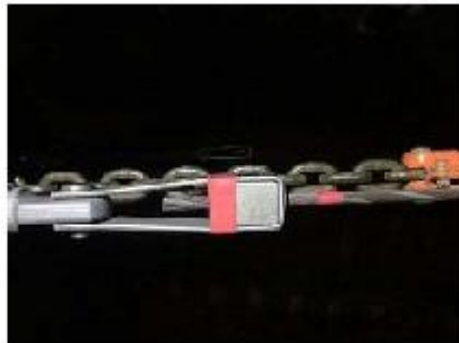
Slippage of OLE catenary wire in of Bonomi forked collar

On Friday 5 May 2017 an inspection by the EGIP team discovered that the Overhead Line Equipment (OLE) catenary wire within a Bonomi forked collar socket C21/544/001 had slipped from its original installation position.

Whilst the wire remained anchored there is the potential that further slippage would result in an OLE de-wirement. This was the third reported slippage of the black catenary Bonomi Forked collar on EGIP K01 since April 2017.

This was also similar to incidents which occurred between January and March 2017 which were originally attributed to installation error. The latest incident raised concerns around the root cause of these incidents.

This update is being issued following independent testing which concluded the slippage occurred as a single event and not after full line tension was applied. The safety advice below has been updated to reflect the results of the testing.

- Any Bonomi forked collar sockets that are installed to final system tensions do not require further monitoring after an initial visual inspection.
- If the tension of any catenary wire is modified or disturbed then any Bonomi forked collar socket is to be replaced at the time of those works.
- The previous action requiring periodic inspections has been rescinded.
- Any safety rigs installed can be removed if there is wire protruding past the end of the collar.
- The Network Rail Product Acceptance, PA05/06543, of the Bonomi forked collar sockets, 091/029042, 091/029043 and 091/029044, has been suspended and the product shall not be installed on Network Rail infrastructure.
