Safety First Briefing

February 2018

Safety: The Importance of Safety Briefing

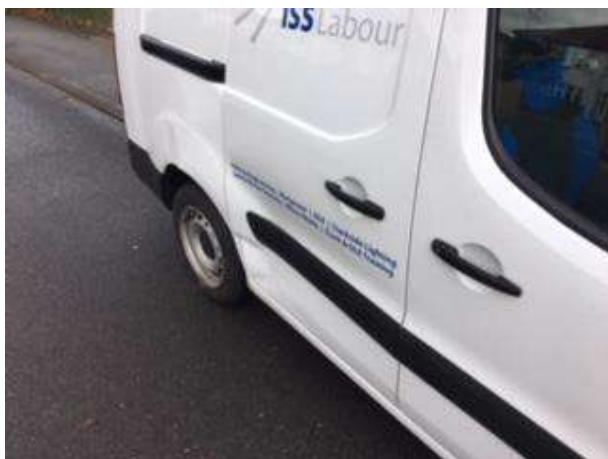
MW16 NTG

Description: Vehicle ran-over rough ground that was raised and covered in ballast. This caught the underside of the vehicle.

Damage: Damage to the front underside.

Outcome: The driver is at fault. Designated roadways should always be used.

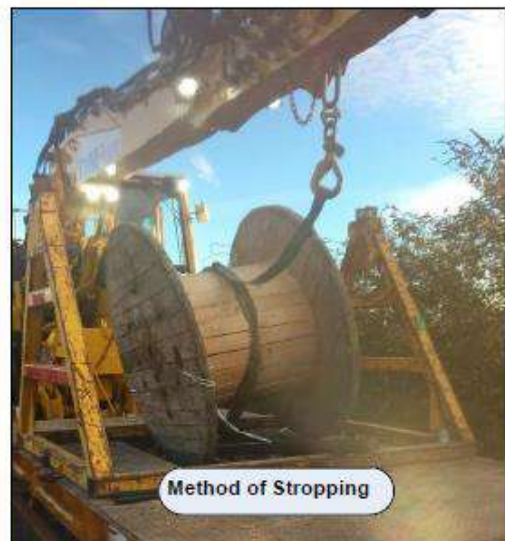
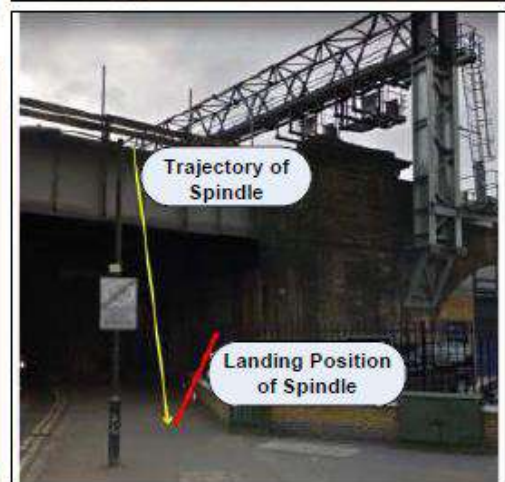
Issue Number: TLP083 Title: Cable Drum Spindle Fall into Public Area

On 19th November 2017 at 13:00hrs, a track team was lifting an empty cable drum from an 'A' Frame mounted on a track trailer. During the lift, the cable drum spindle bar snagged on the 'A' frame. On further attempting to lift, the drum jerked and tilted causing the spindle bar to slide from the centre of the drum. The spindle bar fell through a gap in the parapet wall approximately 8m to the ground below, into a public area.

The spindle bar weighs circa 50kg and is approximately 2m in length. The spindle bar did not come into contact with any persons or vehicles when it fell however, it had the potential to cause significant injury and/or damage.

Immediate: Insecure spindle bar sliding from slung cable drum.

- Inadequate assessment of the worksite and lack of detail in the Task Brief in relation to working around bridges/viaducts.
- Neither the Task Briefing nor Point of Work Risk Assessment (POWRA) considered or addressed the risk of lifting on under-bridges or viaducts.

- The Lift Plan was generic for lifting activities and lacked specific detail.
- Although the Lift Plan showed that whilst lifting on viaducts & under bridges was a hazard, it failed to identify any controls to mitigate the risk.

- The Crane Controller & Supervisor believed that the collars on the spindle were there to prevent the spindle coming out of or through the cable drum whilst lifting, rather than controlling drift and keeping the spindle on the 'A' frame.

- The drum was incorrectly slung with a single Strop allowing it to tilt.
- Lack of competence/experience of the team in lifting cable drums.
- Cable drums had been stored on their sides on the trailer.

- Communication issued to the project/supply chain that lifting must be carried out in accordance with the Principal Contractor 'Lifting operations: Our Expectations' process.
- Going forward, diagrams/instructions to be included in cable drum Lift Plans, including stopping arrangements.
- Safety Bulletin issued – 'Lifting of cable drums on bridges and the correct procedure for lifting, including the prohibition of lifting on viaducts /under bridges without a detailed Risk Assessment'.
- Project instructed to place all cable drums into the correct storage position on their rims.
- Mandate and train supervisors in the use of Lift Plan assessment sheets and POWRA (point of work risk assessment).
- Re-training and assessment of the Crane controller involved in the incident, followed by a period of mentoring.

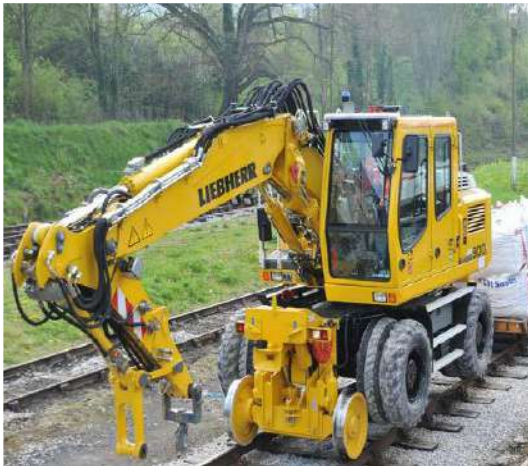
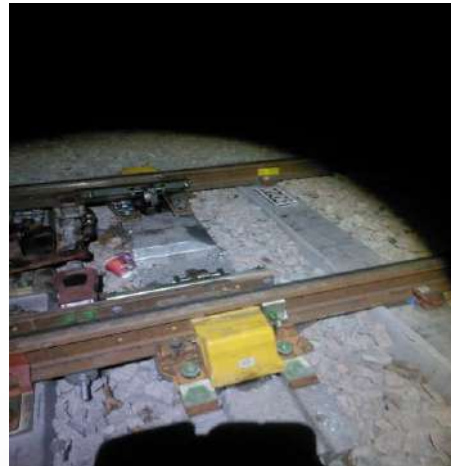
SAFETY BULLETIN – 04-18 TITLE: Liebherr A900ZW - Suspended from BGCL Rail Projects

It was discovered that a series of Clamp Lock Deflector boxes (see yellow box on the top right picture above) on various locations of points areas had been damaged on site, some were cracked and some were broken.

A Safe Work Leader undertook a review on site and it was suspected the above plant had potentially caused the damage, as the rubber wheels passed over the deflector boxes. 17 boxes were replaced on site.

Because of this incident **ALL** Liebherr A900ZW have been suspended from any further use on Buckingham Group Rail Projects until further notice or unless authorization is given by a Buckingham Director. When using any low rider type machine, always ensure an adequate risk assessment has been completed and adequate controls put into place to mitigate any risk of the machine coming into contact with Clamp Lock Deflectors or other line lineside equipment. Network Rail have banned low riding OTP in the Southern region.

Work that is currently planned using these machines must be re-planned using alternative equipment

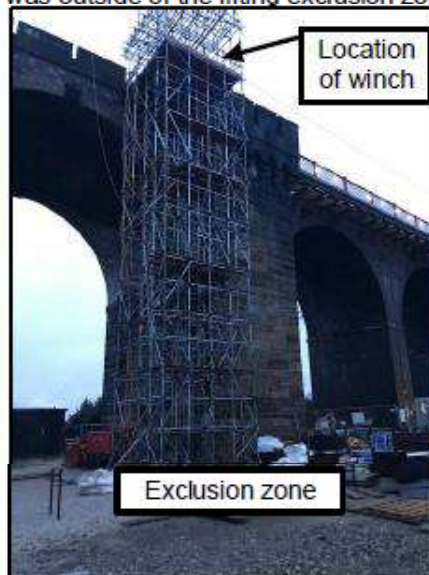
As the load reached the top of the loading bay a gust of wind caused it to become lodged on the scaffold, resulting in the Cordek slipping out of the cradle sling and into the exclusion zone below. No injury was sustained as the operative standing below was outside of the lifting exclusion zone.

- The operatives were signed onto a task brief sheet however it did not cover the use of the hoist system.
- There was no lifting plan in place.
- There was no system in place to prevent unauthorised use of the hoist.
- The operatives did not hold any form of training for the winch system or for slinging, and therefore the incorrect sling technique was utilised.

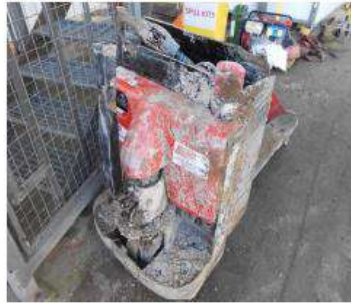
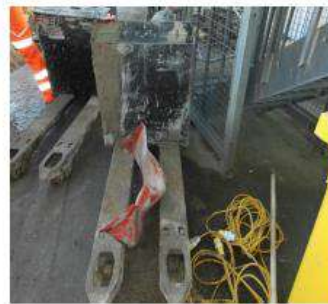
An electric pallet truck being utilised on the Liverpool Lime Street project fell from a platform when the forward/reverse button became stuck.

The operative was uninjured though the pallet truck was damaged (as per the photos above) and leaked a cup full of battery acid. The leak was contained / bagged and placed in the COSHH store. The pallet truck was later removed and quarantined.

- Prior to usage the keys will need to be obtained from the Site Supervisor and a signature obtained from the operator upon receipt of the key.
- A Pre-Use Check Sheet has been prepared and will be undertaken on each electric pallet truck by the designated operator with records maintained. After usage at the end of each daily shift, a check sheet will be completed for the pallet trucks to search for any damage to the equipment with records maintained and the Site Supervisor informed, where required defective items of plant shall be quarantined.

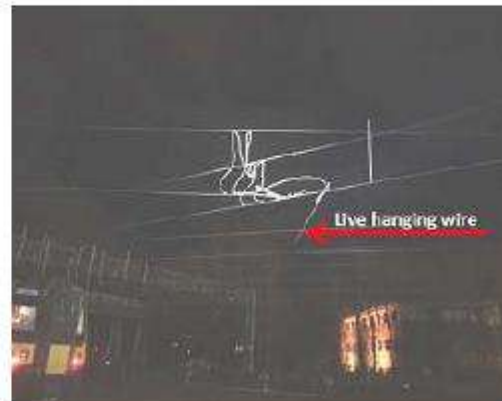
An overhead line incident occurred at the North end of Crewe station.

The overhead line contact wire parted as an electric train passed causing damage to the train's pantograph and resulting in the contact wire hanging down.

When overhead line staff arrived they found that staff had been walking in close proximity to the live contact wire that was hanging down. An emergency switch off had not been requested.

The parted contact wire is believed to have been within 30cm of head height and staff had walked beneath it. In September 2014, less than 25 miles away, a train driver suffered extensive electrical burns in very similar circumstances when they left the cab after the overhead line had been damaged.

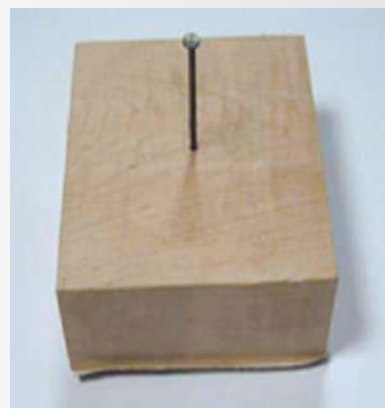
Don't

Nails can become “snake fangs” if used incorrectly or left protruding in timber.
