Safety First Briefing

November 2017

Accidents and Incidents

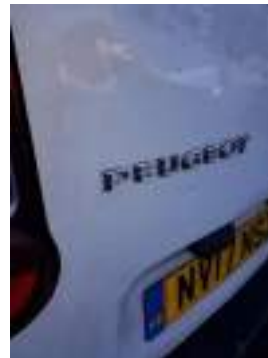
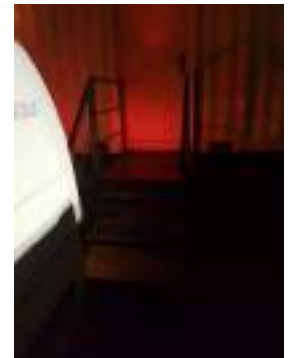
NV17 NSZ – 07/10/17

Driver arrived at Tallington access road point, when reversing into the parking bay in between two vehicles. The vehicle struck the steps of the cabin due to poor lighting and that the steps were painted black. Minor damage was caused to the vehicle.

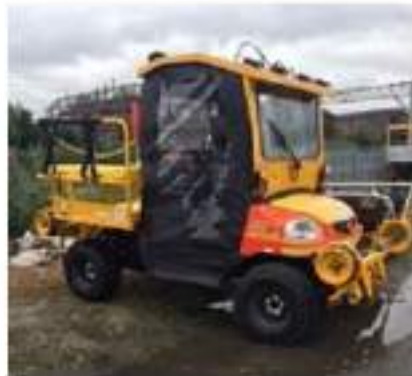
Kubota placed on line open to traffic

At 00:02 on 3 January 2017 a Kubota road rail vehicle was placed on an open goods line during a T3 possession of the adjacent main lines at Rookery Bridge between Crewe and Sandbach.

The Engineering Supervisor (ES) was unfamiliar with the location and referred to the main lines at this location as both the "Manchesters" and "main lines". The Controller of Site Safety (COSS) took this to mean the Manchester independent goods lines.

The access point cited in the Safe System of Work Pack (SSOWP) was Rookery Bridge, however this is located on the goods lines side of the railway and therefore is not viable when the goods lines are not included in the possession.

The ES was not familiar with the location and had not attended a site visit or the planning meetings.

The ES was sourced from a contingent labour provider and the team dynamics of them managing local in-house teams had not been recognised.

The ES conducted their briefing with one of the working parties over the telephone compromising clarity and restricting the chance to check understanding, including signed acceptance of the worksite details.

The SSOWP takes access point data from the National Hazard Directory (NHD) which allowed Rookery Bridge to be selected despite the goods lines not being included in the possession.

The Person in Charge should be involved in the planning – a key factor is to make sure staff such as the ES, the PIC (and if different the COSS) have local knowledge.

Use location names as they are stated in the Sectional Appendix to avoid confusion.

Worksite briefings should be face-to-face to enable staff to sign their acceptance of the worksite details.

Attending site visits and planning meetings is of vital importance for safety critical staff.

The NHD is not 100% accurate and any discrepancy should be raised with the local Systems Support Manager.

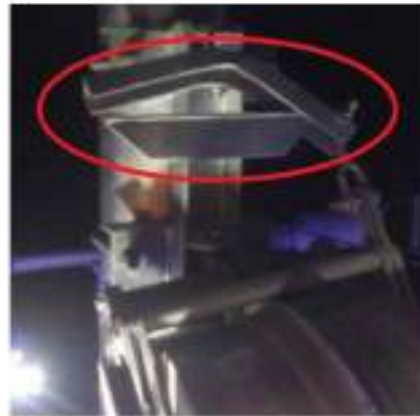
Failure of Tensorex C+ upper fitting bracket in OLE

On the evening of 28 August 2017 the failure of a Tensorex Upper Fitting Bracket (Pfisterer part number 042216) was discovered in the Overhead Line Equipment (OLE).

Investigations indicate that the failure of the bracket was caused by poor quality welding of the stiffening plate during manufacture. This in turn caused a secondary failure of an M14 terminal fork.

The inspection should focus on the quality of the welds; damage to the weld and insufficient welding of the stiffening plate.

Any unit which has been fitted with the 042216 upper fitting bracket, and has subsequently failed the visual inspection should be retrofitted with a replacement part fully compliant to the design specification at the earliest possible opportunity.

All locations of failed units shall be reported to STE.

To assist with future identification of any Tensorex C+ units which have passed the inspection criteria, or are retrofitted with a replacement upper fitting bracket, shall be clearly identified by way of yellow dots on the underside of the upper fitting, directly below both terminal fork positions.

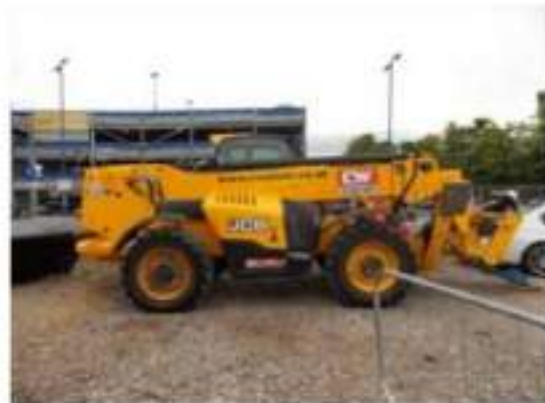
Location: High Wycombe Station

On the 30 August 2017 at High Wycombe Station, an operative was seriously injured when he, sustained crush injuries from a JCB tele-handler.

Whilst positioning a section of "bog-mat", the operative became trapped at the front of the machine sustaining multiple injuries including fractures to their leg, and is currently in hospital recovering from these.

- How do we make sure that exclusion zones are adequate for the tasks being undertaking?
- How do we know who is responsible for maintaining the exclusion zone?
- How do we make sure that the driver understands the task they are to perform?
- How are ground and weather conditions considered before operating plant?
- How do we set up clear communication channels between the driver of the vehicle and operative on the ground?
- How would you check that the machine has been correctly maintained?
- How do you know the operator is authorised to drive the machine?

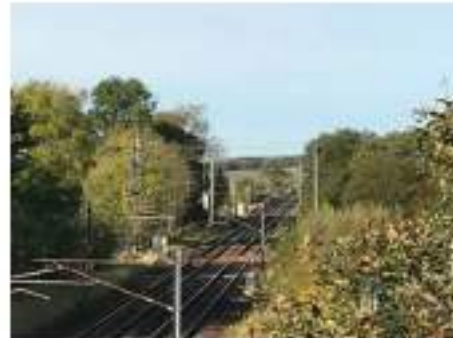
Location: Ecclefechan, Dumfries & Galloway

On the morning of 29 September 2017 red zone working, by use of Lookout Operated Warning System (LOWS), was in place by to allow survey work for the High Output team to take place.

Immediately after the incident the COSS called the LOWS operator who had failed to warn of the oncoming train. The operator highlighted he had not seen this train passing his location, although they had not missed any prior to this event.

- How can we manage the risk of fatigue in LOWS operators?
- What can you do to better protect the safe system of work from fatigue and concentration issues of staff carrying out LOWS duties?
- How do you provide increased sighting distance due to foliage obstruction?
- How do you take account of any changing conditions, for example new vegetation growth?
