Safety First Briefing

March 2018

A note from Brian Madden, Head of Safety for ISS Labour Ltd:

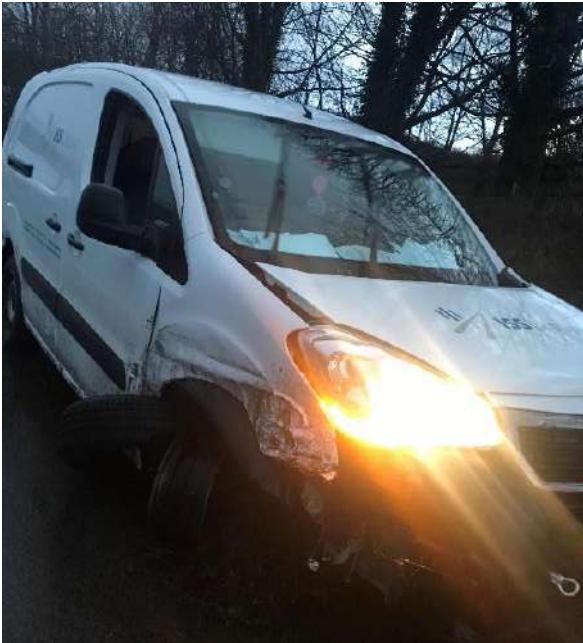
PJ16 PRX

Description: The driver was heading home on the M62. Due to the heavy sleet and poor driving conditions, the rear of the vehicle lost grip and started to veer off towards a HGV. The driver pulled the car back which caused it to collide into the central reservation.

Damage: Driver Wing and wheel

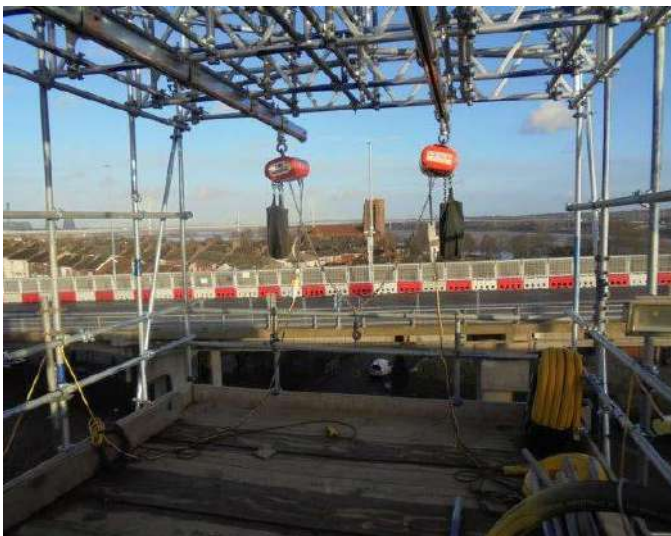
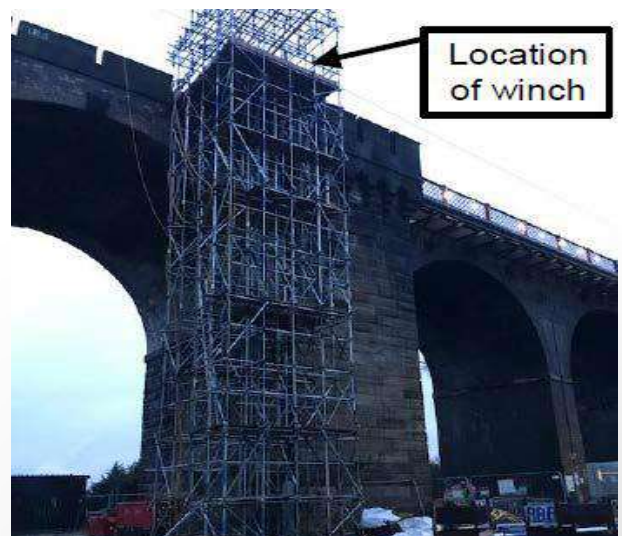
Safety Bulletin – SB05-18

Two loading bays are being used on the Runcorn Viaduct Project at each side of the main span, to load materials and equipment on to the structure. The loading bays were fully compliant and signed into operational use in October 2017 as part of the temporary works requirements. The project has had 2 unconnected incidents during lifting operations using the electric hoists attached to the loading bay frame.

Following a review of the loading bay methodology by the project team including members of the sub-contractor team from Taziker Industrial, it was highlighted that some improvements could be made to the loading bay and equipment used to undertake the lifting operations. It was agreed to suspend further lifting and to carry out a full review of the current temporary works design with a view to make improvements to prevent any future accidents or incidents. This decision is likely to cause the project some delay to programme and additional costs to redesign and implement changes but was considered good practice and the right thing to do to minimise & reduce the risks identified.

The project team are reviewing the current approved design and will make the required changes to the loading bay before signing back into operational use.

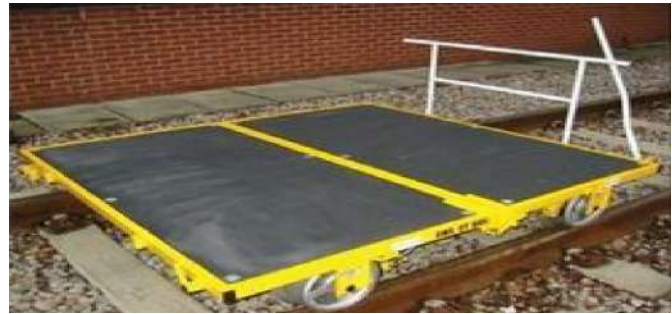
The operatives then made their way around to Runcorn Station RRAP. The distribution of materials was underway and at the time of the incident 25kg type 1 MOT bags were being distributed to the maximum of 1 ton. There were 3 track trolleys in a chain; The IP was the middle track trolley with a Track Trolley in front and a further trolley behind.

Whilst the IP was pushing the trolley he stopped to change his grip on the handle, the following track trolley did not realise quick enough that the trolley in front had stopped and applied the brake but was unable to prevent the track trolley coming into contact with the IP's leg. The IP did try to jump clear after receiving a warning but was unsuccessful and the trolley struck the back of his leg causing swelling.

The track trolley was immediately quarantined after the incident and the supplier called to attend site the very next day to carry out a break test. The service report confirms the breaks were well above the minimum brake force of 80nm. Wheel (1) 139.8nm and wheel (2) 126.0nm.

- ☐ Is a track trolley the most suitable piece of equipment for the task being carried out?
- ☐ Have the hazards and controls measuring for the use of a track trolley been implemented into the Risk assessment, work Package plan and Task briefing with the controls fully understood?

- ☐ Have you ensured the track trolley complies with NR/L2/RMVP/0200 module P513 (Issue 3)?
- ☐ How do you ensure the equipment being used is fit for its intended purpose?

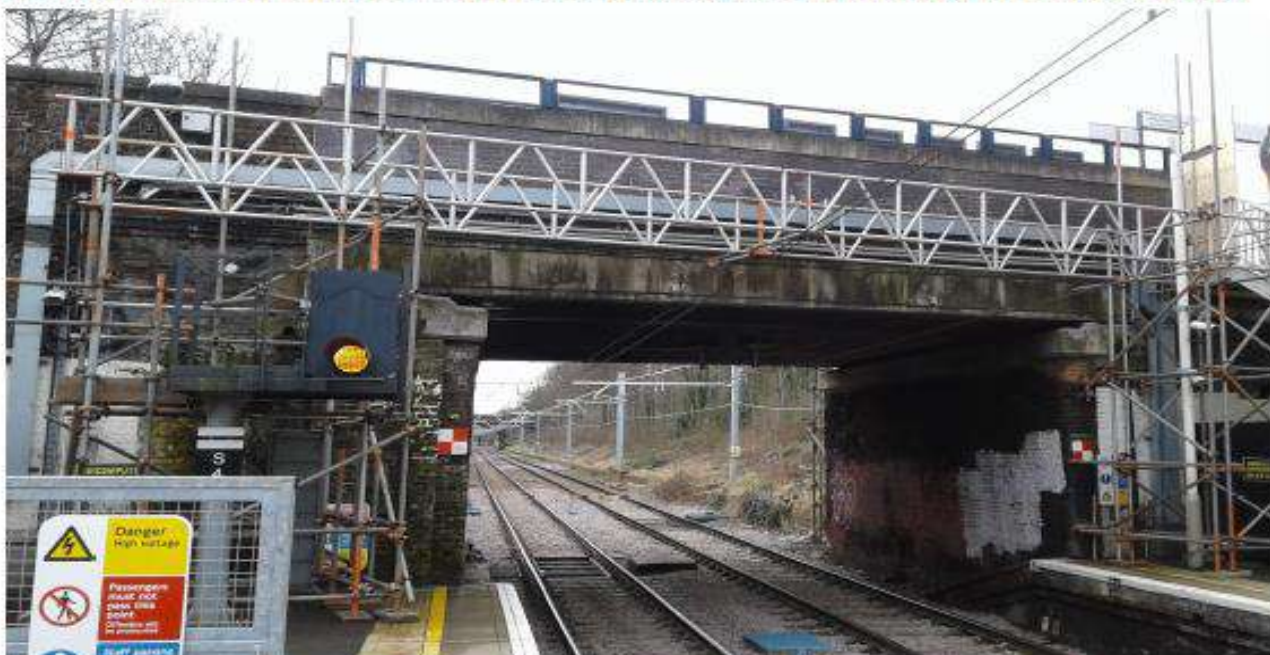
CROUCH HILL - UNBONDED SCAFFOLD

The scaffolding structure was erected above the overhead line equipment (OLE) and at the current time, the overhead line equipment is not fully energised. However, there is a possibility for the overhead lines to become energised for testing purposes and for this reason, it was agreed that the scaffold structure would need to be electrically bonded (earthed) to allow for any electrical current affecting the scaffolding to dissipate safely.

During a routine site visit that was carried out today, it was noted that the temporary electrical bonding had not been applied to the structure following its erection. This could cause a "touch potential" hazard for any person that may have come into contact with the scaffolding structure.

Additionally, the scaffold support towers located at the end of the platforms had no anti climb fencing fixed to them causing an additional trespass and unauthorised access hazard.

Currently, all work on site has been suspended and remedial work is being undertaken to install the electrical bonding via connection to the signal structure.

Additional fencing is also being installed to the platforms and the access bridge to prevent access onto the scaffolding.

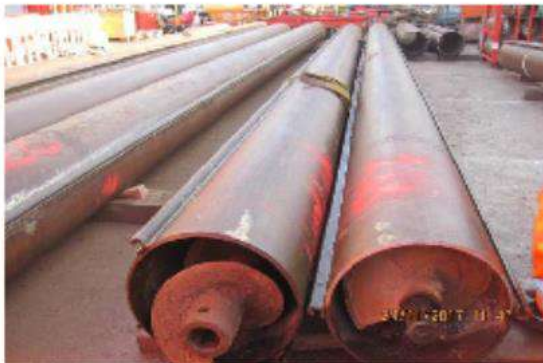
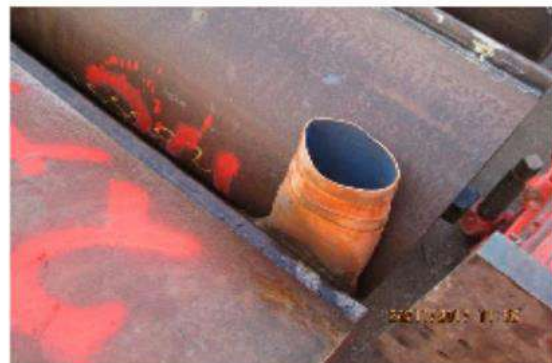
RIDDOR Injury from Foot Trap at Newton le Willows

The Supervisor (IP) was carrying out a pre-lift inspection of the auger tubes and was standing in-between the tubes. There was an issue with the location of the lifting straps which required one of the straps to be moved. This was carried out, by attaching the crane lifting gear to one end of the tube to lift the tube slightly to adjust the straps.

The near side tube end was lifted off the ground by the crane operator without the permission of the Slinger/ signaller. On noticing this movement, the slinger/ signaller gave the crane operator the instruction to lower.

As the tube was being lowered back to ground level, the tube rolled off its existing resting place towards the other tube, resting against it, but also trapping the IP's boot/ foot between the two tubes.

Exclusion of the workplace: Ensure when materials are to be lifted or moved, that all persons are removed from the area prior to lifting taking place.

Storage of materials: Materials of this nature (circular in size and dimension) tend to move unexpectedly when being lifted or moved. Therefore materials must be stored in a safe manner, in this case ideally in purpose made stillage's, adequate in size for safe storage and safe future handling.
