Safety First Briefing

November 2017

Accidents and Incidents

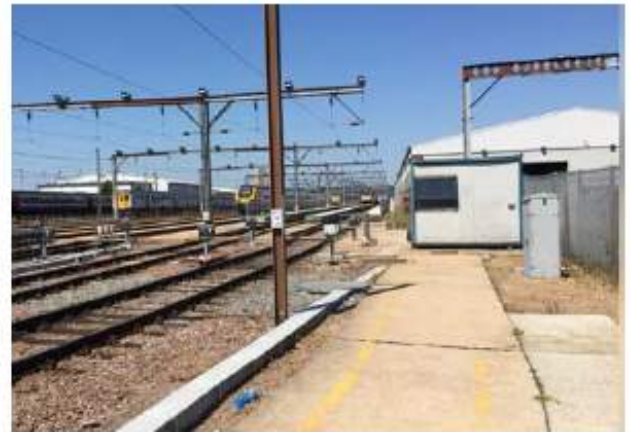
In this instance the life saving rules were adhered to. The AP performed his duties to the book, preventing a potential life threatening incident

ALWAYS TEST BEFORE APPLYING EARTHS

This highlights the importance of the Network Rail life saving rules and why we should always follow them.
