Control of railway fog signals (detonators)

Ref: NRB 17/05

Date of issue: 17/03/2017

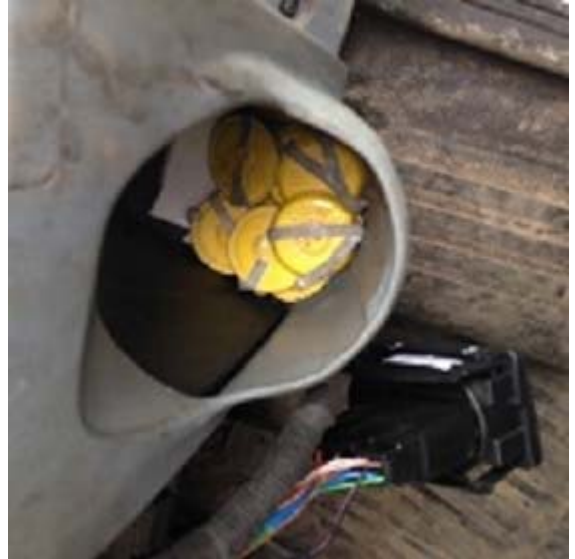
While carrying out fieldwork for a road fleet maintenance audit at Newcastle Delivery Unit's Raven House an auditor noticed fog signals (detonators) present in the vehicle's cup well.

Further checks were made and in another vehicle detonators were again present in the front cup well.

The event was reported to local staff and management who quickly rectified the issue and a close call was raised reflecting the auditor's concern.

Detonators are subject to strict controls over their distribution, storage and use as detailed within Group Standard GEGN 8532 and Operations Manual procedure NR/L3/OCS/041 2-10. Given this:
