Safety First Briefing

October 2017

Accidents and Incidents

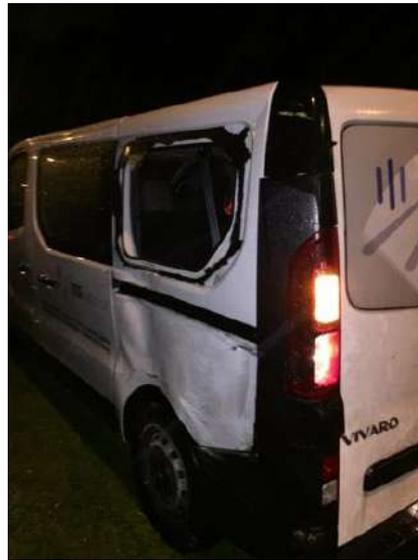
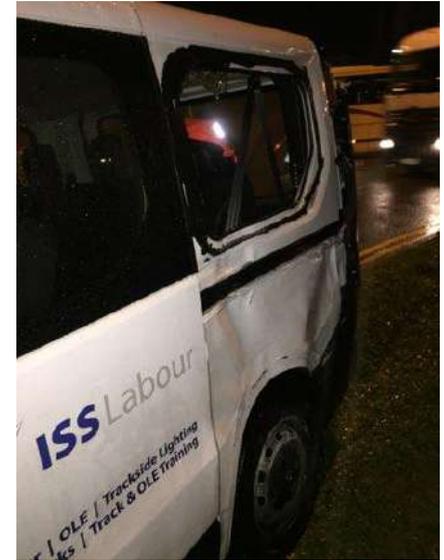
20/09/17 – YG160CP

Driving home following the diversion on the M4, driver was indicating to exit when a bus in the left hand lane attempted to go all the way around the roundabout causing a collision.

The bus caught the near side rear of our vehicle causing damage to both vehicles.

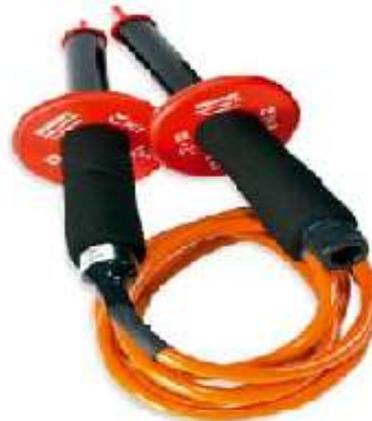
Failures of Seaward 750V DC live line testers

The manufacturers of the Seaward Live Line Tester (LLT) used by staff on the 750V DC electrified network have advised that there are a small number of units in circulation that have a manufacturing defect that can result in the tester being polarity sensitive. The result is that the tester can, depending on which contact is applied to the conductor rail, give a "dead" indication when the rail is in fact still live. As designed, the tester is not polarity sensitive and can be applied either way round.

Advice provided by Seaward is that the Live Line Tester should be proved both ways round on the proving unit to confirm correct operation prior to, and after, use. Not doing so may result in a tester with a fault appearing to indicate correctly when proved, then, if reversed, indicate incorrectly when applied to a conductor rail that is still live.

- All staff involved in conductor rail testing for any reason and using a Seaward LLT shall test the unit for correct operation against the proving unit both ways round before testing the conductor rail, and again afterwards.
- Any Seaward LLT units that show a live indication when applied to the proving unit one way round, and not when applied the opposite way round, shall be withdrawn from use, quarantined and returned to Seaward for replacement. For Network Rail staff, this should be via the responsible E&PME.

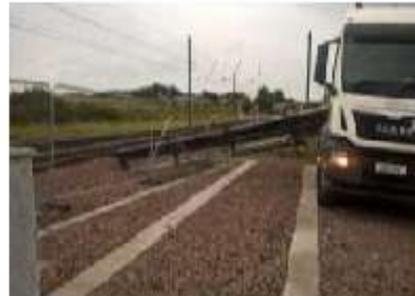
Dangerous incident involving a lorry mounted crane

Rolls of geotextile were being delivered for a forthcoming track renewal on the East Coast Main Line at Reston, Berwickshire, using a flatbed lorry with lorry mounted crane. Two members of contractor staff were present: the lorry driver and a Technical Officer involved with the delivery of the core renewal.

The delivery took place within a yard adjacent to the railway, which was open to traffic with the OLE energised. Temporary Heras panel fencing had been erected to prevent staff working in the yard from encroaching upon the running lines.

After offloading, the driver started to stow the crane away in preparation for leaving site. At this point, an apparently uncontrolled extension of the jib took place towards the running lines, immediately followed by the collapse of the jib to the ground. During these uncontrolled movements, the end of the jib snagged the return conductor, dragging it down and damaging a panel of the temporary fence.

Fortunately there were no injuries and only minimal damage to the infrastructure, but there was significant disruption to services on the East Coast Main Line while the crane jib was recovered and staff checked the OLE for damage.

- How do you plan and supervise road deliveries of materials to access points and yards?
- What precautions do you use when working adjacent to open running lines and live OLE?
- How do you know staff are fully trained and competent to use specific lorry mounted cranes and the associated remote control equipment?
- Is all lorry mounted lifting equipment regularly serviced, inspected and tested in accordance with the mandated schedules?

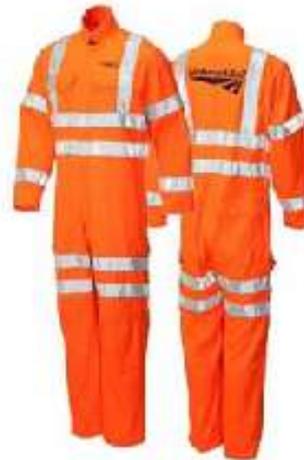
Arc Flash PPE

Following recommendations from electrical safety incidents that have occurred, arc flash PPE has been issued for use by Distribution and Plant staff.

Distribution and Plant staff shall wear their current issued arc flash PPE when:

- Performing local switching operations directly at the switchgear panel.
- Performing testing and earthing activities including applying or removing portable earths prior to safety document issue or under a sanction for test.

- Returning to service withdrawable switchgear onto an energised busbar.
- Synthetic, nylon and/or polyester materials should not be worn underneath the PPE. Wearing natural, 100% cotton, clothes as undergarments, such as jeans and a long sleeved shirt, is recommended.

- These requirements are to be incorporated into the updated version of Task Risk Control Sheet DP01 – Working on High Voltage Equipment.
- Staff who do not have the required PPE should order such items from the PPE catalogue (Foul Weather FR and ARC Clothing Catalogue). This should be the Flame Retardant Waterproof Coat (FR2) and Flame Retardant Salopette (FR04) or FR Waterproof Over Trousers (FR05).

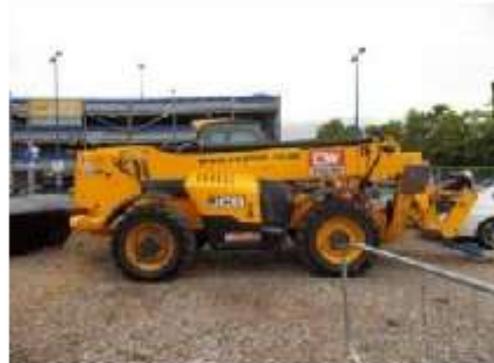
Contact with moving machinery

On the 30 August 2017 at High Wycombe Station, an operative was seriously injured when he, sustained crush injuries from a JCB tele-handler.

The operative was working with the machine operator to lay "bog-mats" in preparation for heavy vehicle access.

Whilst positioning a section of "bog-mat", the operative became trapped at the front of the machine sustaining multiple injuries including fractures to their leg, and is currently in hospital recovering from these.

- How do we make sure that exclusion zones are adequate for the tasks being undertaken?
- How do we know who is responsible for maintaining the exclusion zone?
- How do we make sure that the driver understands the task they are to perform?
- How are ground and weather conditions considered before operating plant?
- How do we set up clear communication channels between the driver of the vehicle and operative on the ground?
- How would you check that the machine has been correctly maintained?
- How do you know the operator is authorised to drive the machine?
